# Manhole Inspection Summary

Manhole # S21KK\_006MH

Insp Date: **5/31/07 9:01 AM**

**Location** Address: **1837 CLIFTON AVE**

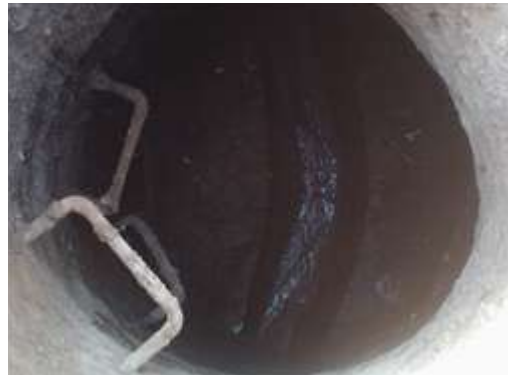
Top View

**Frame** Offset: **2** (in.) Condition: ☒ Sound ☐ Cracked ☐ Leaks

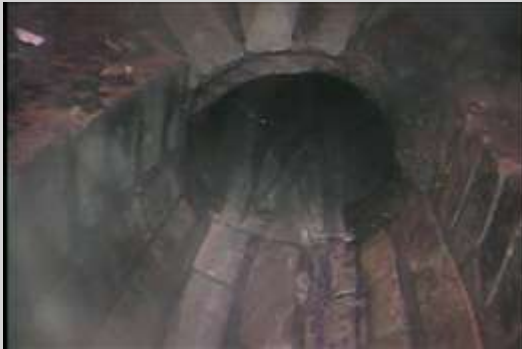
12 O'Clock Outflow

10 in. Circular Gravity Sewer  
Pipe Out @ 12 O'Clock

Pipe Height: **9.6** (in.) Rod and Bar (Angled)  
Pipe Material: **Clay** ☐ Pipe Lined  
Invert Depth: **8.51** (ft.) Flow Characteristics: **Fast**  
Deposits: ☒ None ☐ Mud ☐ Sludge ☐ Debris ☐ Grease  
Silt Depth: (in.) Deposits Extent:  
Infiltration: **None** Pipe Seal Cond: **Sound**
